Name Of Dam: LOCH HAVEN LAKE
Location: ROANOKE COUNTY, VIRGINIA
Inventory Number: VA 16102

PHASE I INSPECTION REPORT NATIONAL DAM SAFETY PROGRAM

PREPARED BY
NORFOLK DISTRICT CORPS OF ENGINEERS
803 FRONT STREET
NORFOLK, VIRGINIA 23510

JANUARY 1981

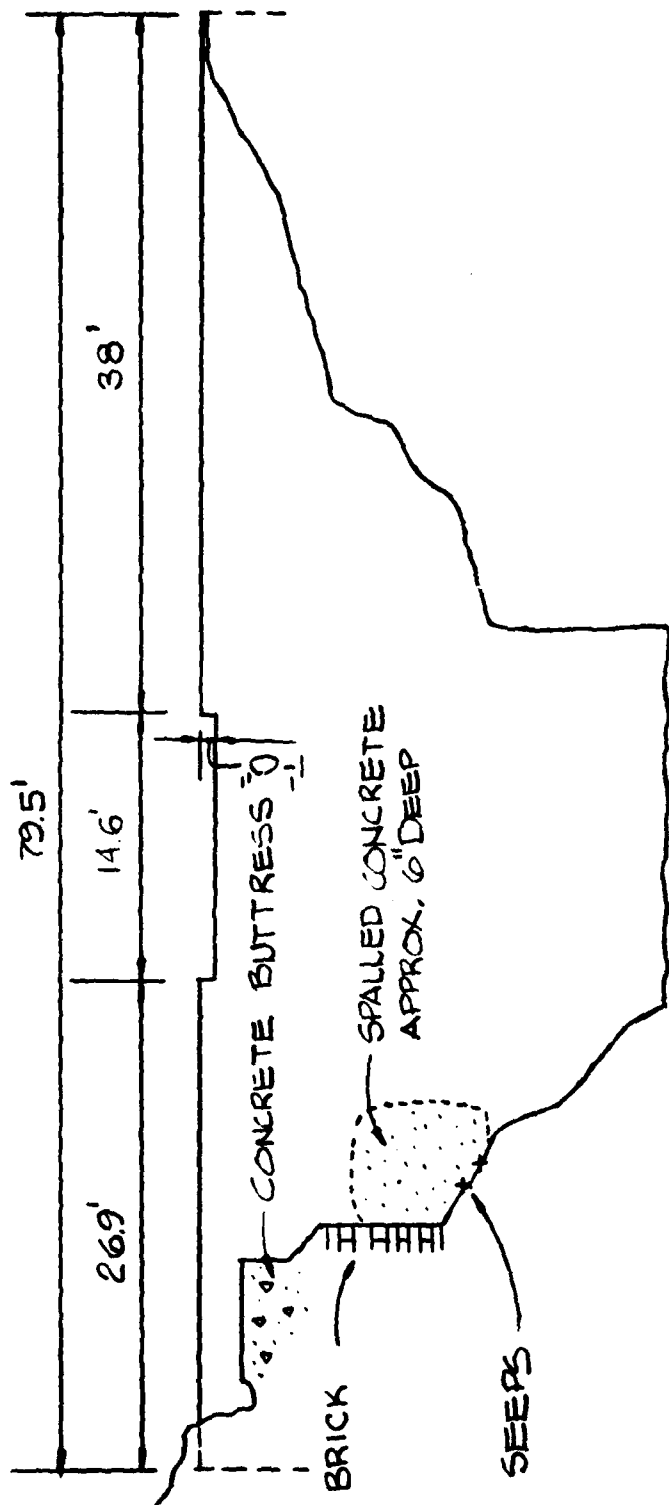
PLATE I

Seepage was observed at two locations along the right abutment contact. These locations are shown on Plate 1. The seepage flow at each location was estimated at 1 gpm. Seepage also was observed 20 ft. from the left abutment at the foundation contact. Flow was very small, little more than a drip, and no estimate of quantity was made.

DOWNSTREAM ELEVATION
LOCH HAVEN LAKE DAM
 SCALE 1"=10'

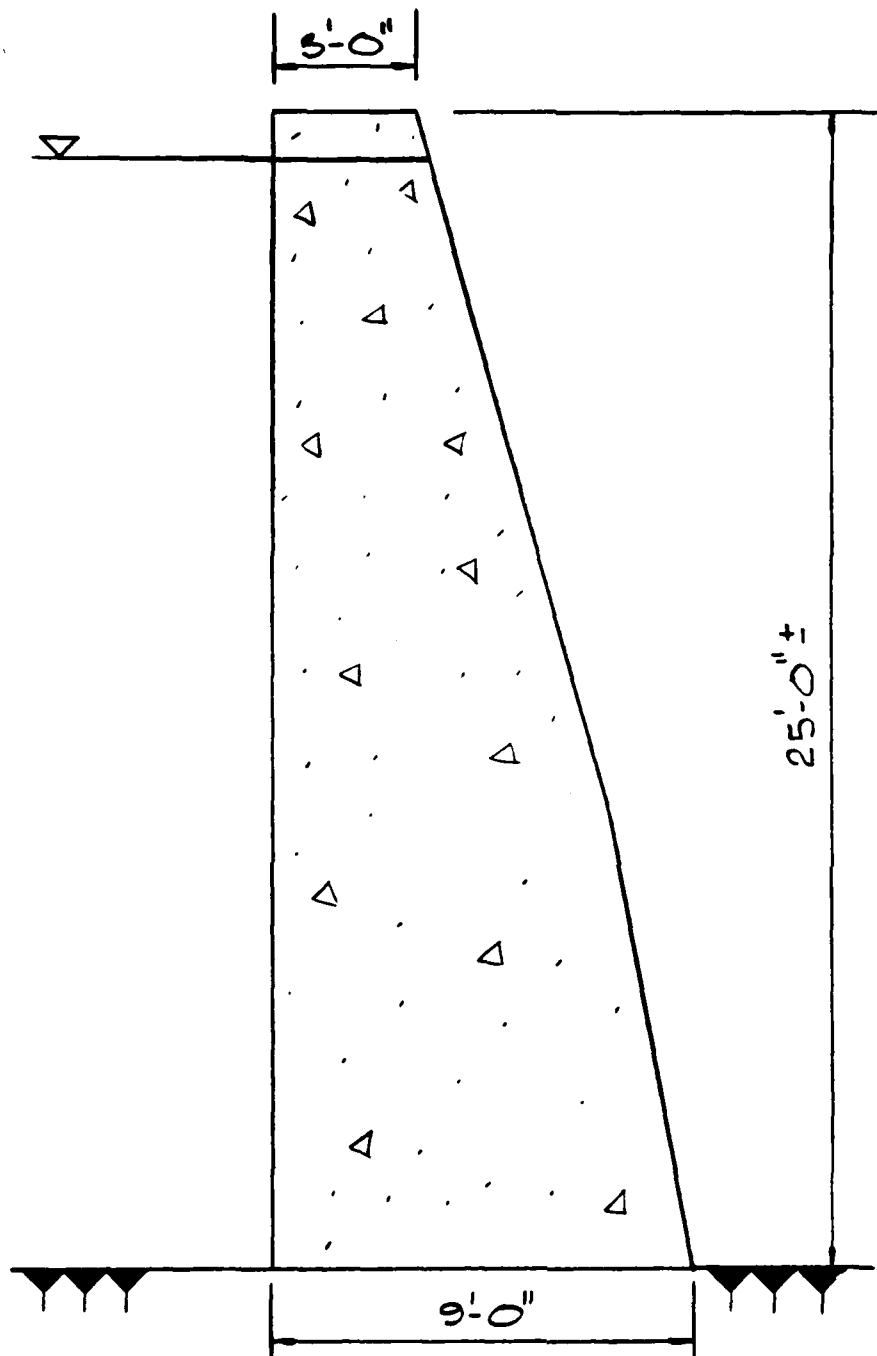
SECTION AT G OF DAM
LOCH HAVEN
SCALE 1/4" = 1'-0"
